Case Study RaySafe X2

Public Dental Care Benefits from Facilitated X-ray QA-testing

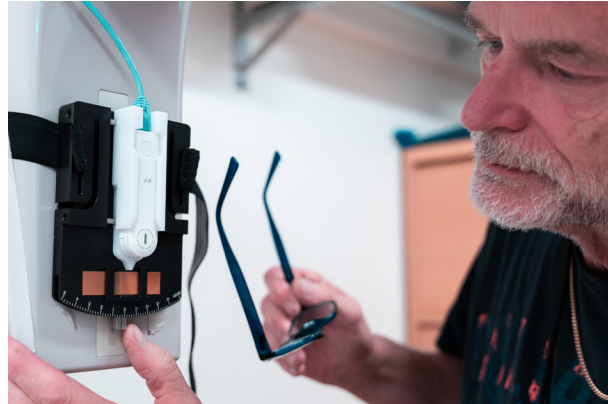
The RaySafe X2 Panoramic Holder is a convenient tool to help position the sensor in the center of the narrow radiation field.

For over 10 years, Jimmy has used the RaySafe Xi/X2 with the R/F sensor. Recently, he added the panoramic holder, which speeds up the pre-work, helping him to position the sensor in the radiation field center. He also uses the Survey Sensor for radiation protection measurements of walls, windows, and other surfaces.

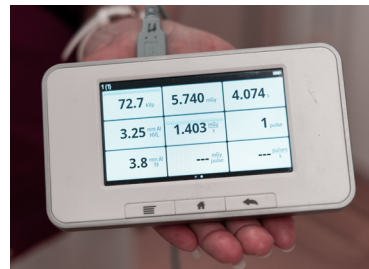
All measurement parameters shown in one window.

“With the RaySafe X2, we can perform all the tests needed to meet Sweden’s national requirements. Tests are fast, robust, and effective—most require just one attempt, and it’s rare to have to repeat a measurement due to issues like a ‘low signal.’ All parameters are displayed in one window, which I appreciate.”
